Detailed Unexploded Ordnance
Risk Assessment

In Respect Of:
Associated British Ports

For:
Immingham Eastern Ro-Ro Terminal

Report Reference:
9048 RA

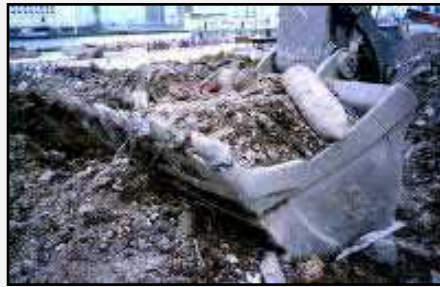
50kg HE bomb, London Docklands

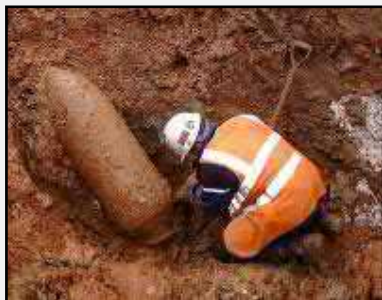
250kg HE bomb, Hawkinge

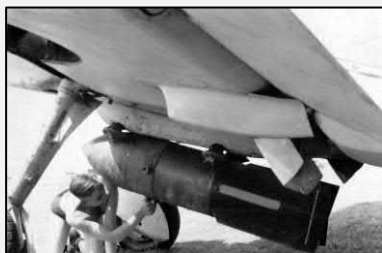
SC250 attached to undercarriage of Messerschmitt Bf109

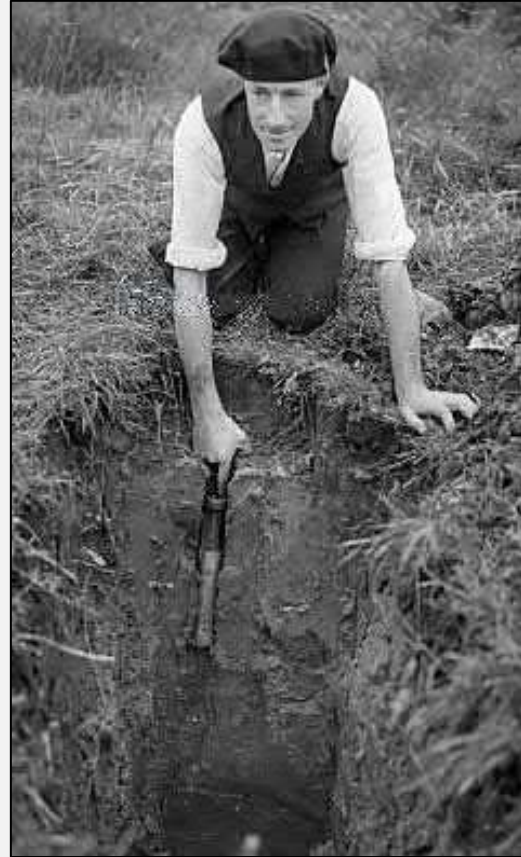
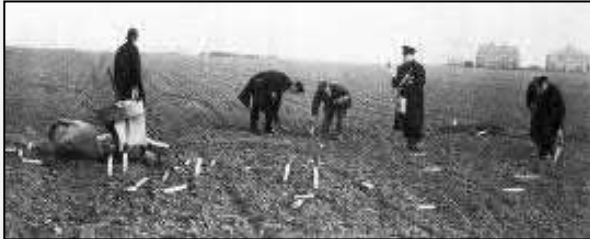
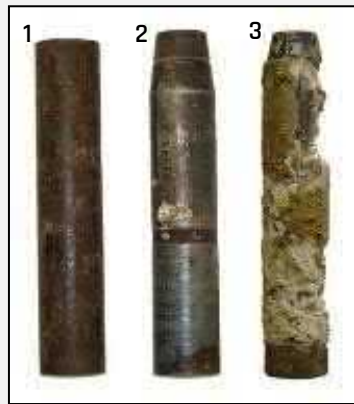
- 1. Ordinary scaffold pipe
- 2. 1kg incendiary bomb
- 3. Incendiary bomb recently found on site in UK

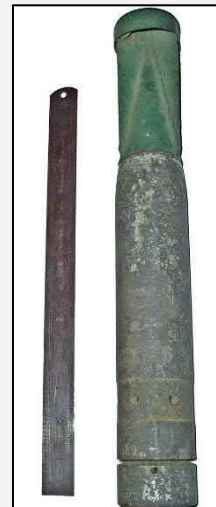
1kg German Incendiary Bomb next to a 30cm ruler

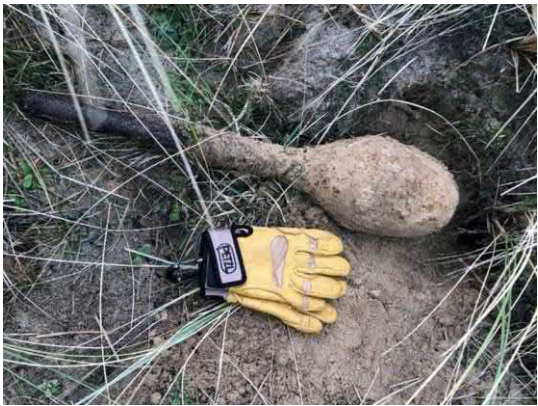
| Home Guard UXO Finds: | |
|---|--|
| | <p>Unexploded Spigot Mortar Round, used by the Home Guard in WWII, found and disposed of in Hayle, Cornwall – January 2021</p> |

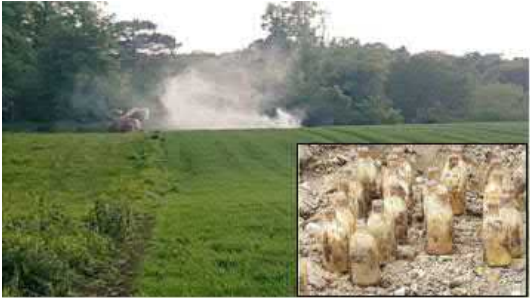
| Home Guard UXO Finds: | |
|---|--|
| | <p>24 x WWII grenades found buried in a field in Sibton, Suffolk – May 2019</p> |

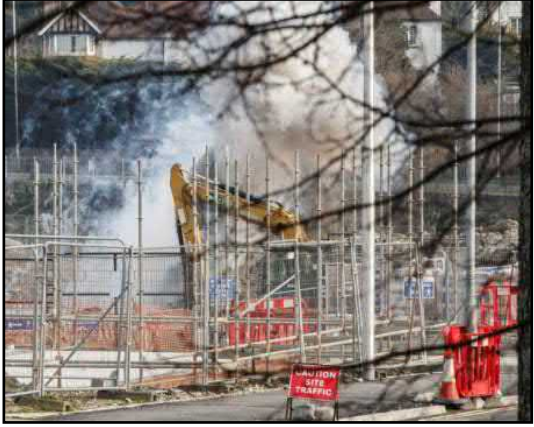
| | <p>A cache of 80 phosphorous grenades buried by the Home Guard found in Eastbourne – September 2015</p> |

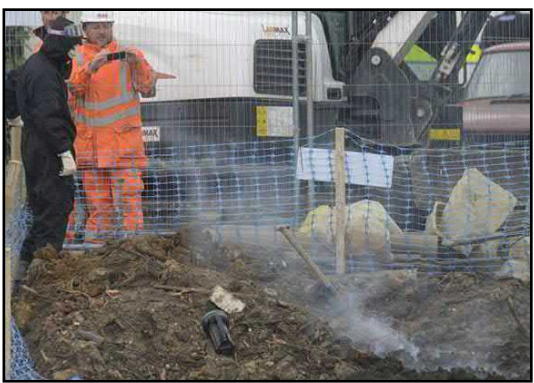
| | <p>Home Guard Phosphorous Grenades found buried beneath a bridge in Herne Bay – July 2015</p> |

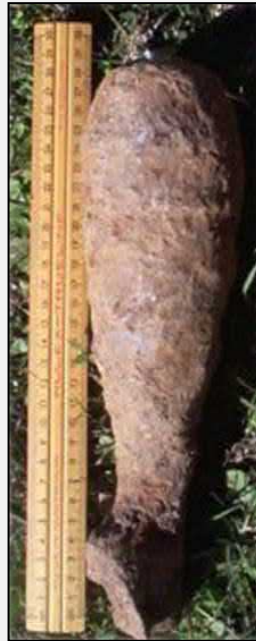
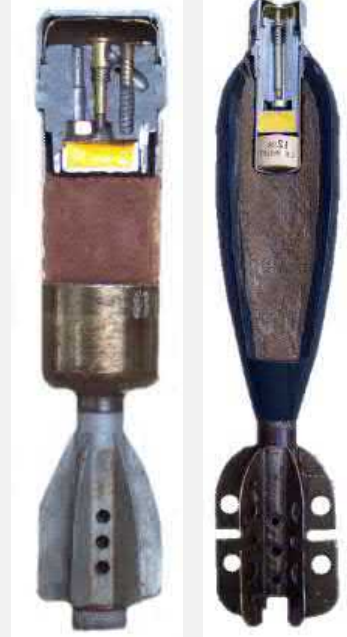
Typical 2" Illuminating Mortar

Remarks: The expulsion charge ignites and ejects the candle assembly. A spring ejects the parachute from the tail cone. The parachute opens, slowing the descent of the burning candle which illuminates the target

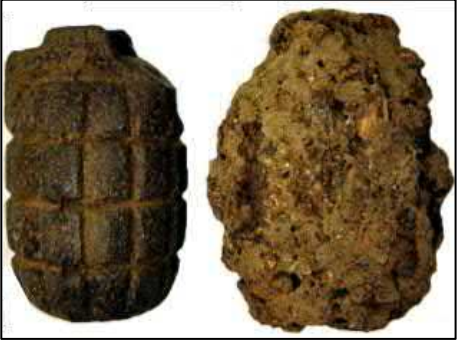
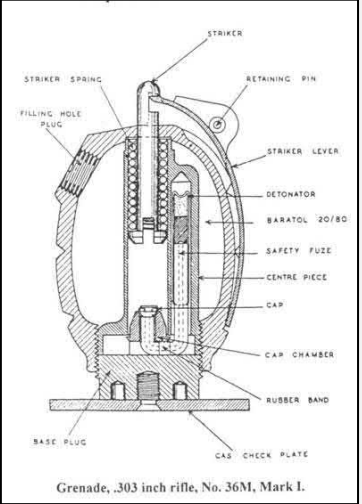
| <p>No. 36 "Mills" Grenade</p> <p>Weight: 0.7kg filled (1lb 6oz)</p> <p>Type: Hand or discharger, fragmentation</p> <p>Dimensions: 95 x 61 mm (3.7 x 2.4in)</p> <p>Filling: Alumatol, Amatol 2 or TNT</p> <p>Remarks: 4 second hand-throwing fuze with approximate range of 30m</p> | | <p>Grenade, .303 inch rifle, No. 36M, Mark I.</p> |

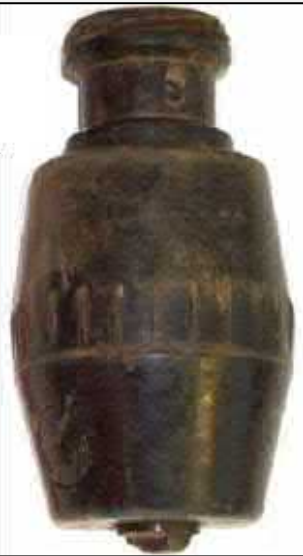
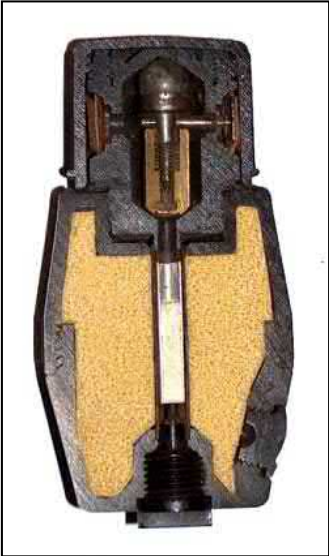
| | | <p>No. 69 Grenade</p> <p>Weight: 0.38kg filled (0.8lb)</p> <p>Type: Percussion / Blast</p> <p>Date Introduced: December 1940</p> <p>Remarks: Black Bakelite body. Blast rather than fragmentation type. After unscrewing the safety cap, a tape is held when throwing the grenade releasing the safety bolt in the throwing motion. Detection is problematic due to it's very low metal content.</p> |

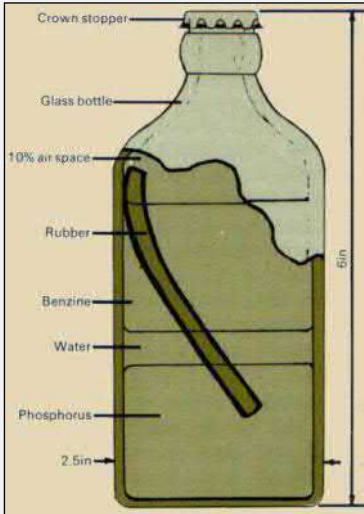
| <p>Self Igniting Phosphorous (SIP) Grenades</p> <p>The grenade comprised a glass bottle with a total volume of approximately 1 pint. It was filled with White Phosphorous, benzene, a piece of rubber and water. Over time, the rubber dissolved to create a sticky fluid which would self-ignite when the bottle broke. Fired by hand or Northover Projector.</p> | | |

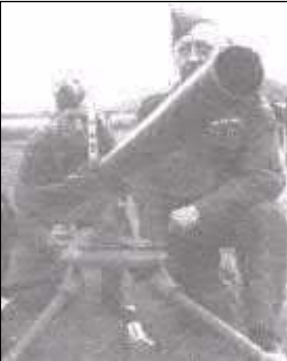
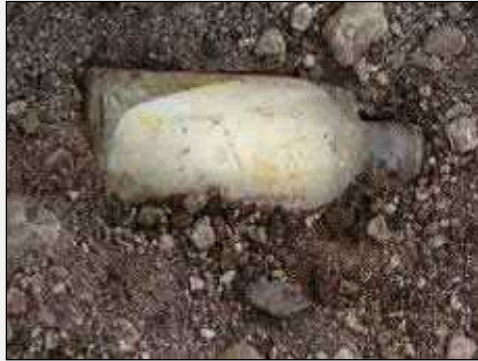
| | | <p>Sometimes called the "A & W" (Albright & Wilson) grenade.</p> |

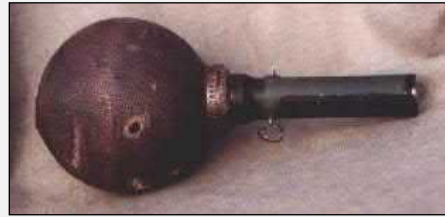
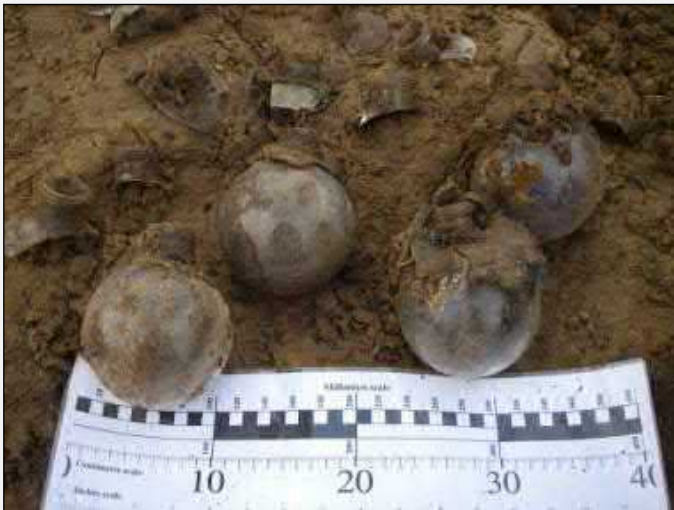
No 74 Grenade (Sticky Bomb)

Designed as an anti-tank grenade and used by the Home Guard. The grenade consisted of a glass ball on the end of a Bakelite (plastic) handle. Inside the glass ball was an explosive filling whilst on the outside was a very sticky adhesive covering. Until used, this adhesive covering was encased in a metal outer casing.

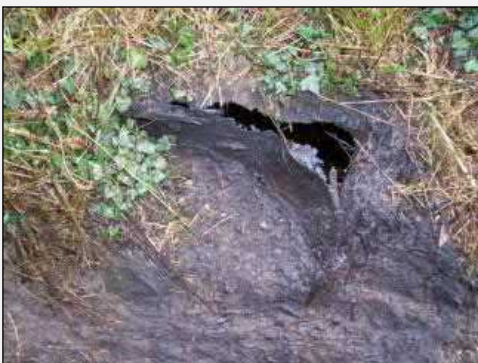
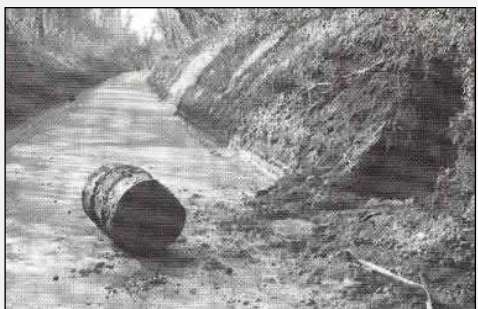
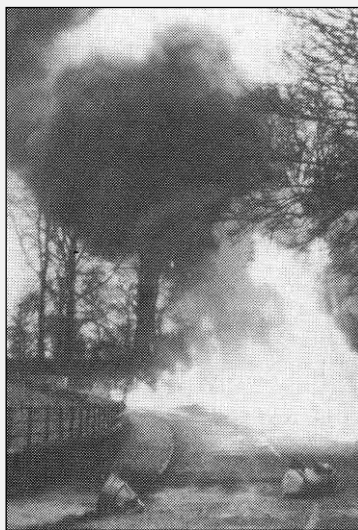
Flame Fougasse Bomb

A Flame Fougasse was a weapon in which the projectile was a flammable liquid, typically a mixture of petrol and oil. It was usually constructed from a 40-gallon drum dug into the roadside and camouflaged. Ammonal provided the propellant charge which, when triggered, caused the weapon to shoot a flame 3m (10ft) wide and 27m (30 yards) long. Initially, a mixture of 40% petrol and 60% gas oi was used. This was later replaced by an adhesive gel of tar, lime and petrol known as 5B.

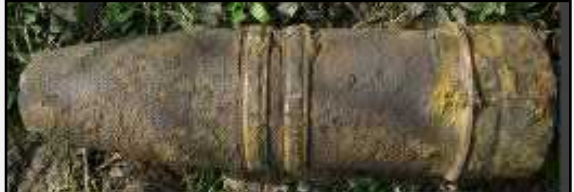
Above: 3.7 inch AA Projectile, Minus Fuze.

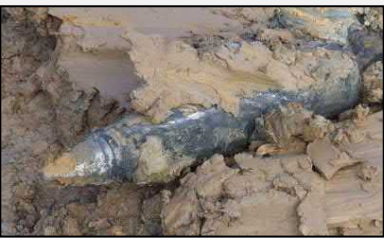
Left: This AA shell was uncovered on a construction site in North London in February 2000

Right: Hyde Park 1939 3.7" QF gun on mobile mounting

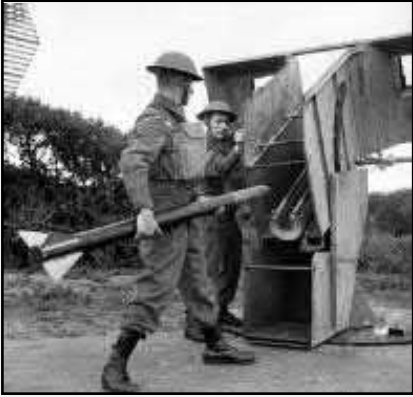
Home Guard soldiers load an anti-aircraft rocket at a 'Z' Battery.

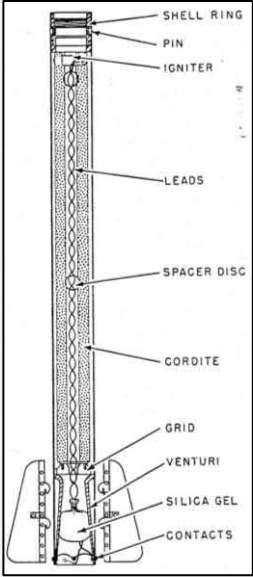
2" U.P AA Rocket.

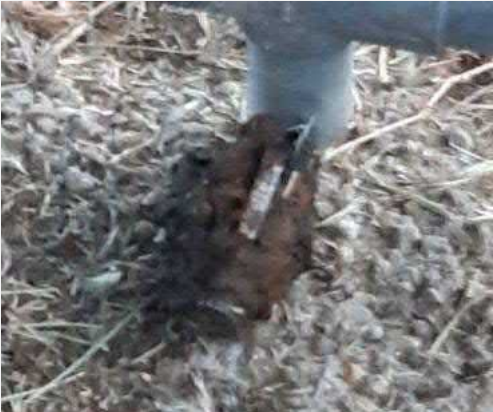
| Item(s) Discovered | Details |
|--|--|
| <p>WWI-era Grenade</p> | <p>July 2021 – Hand grenade found in the River Trent, near Wilford Toll Bridge, Nottingham.²²</p> |

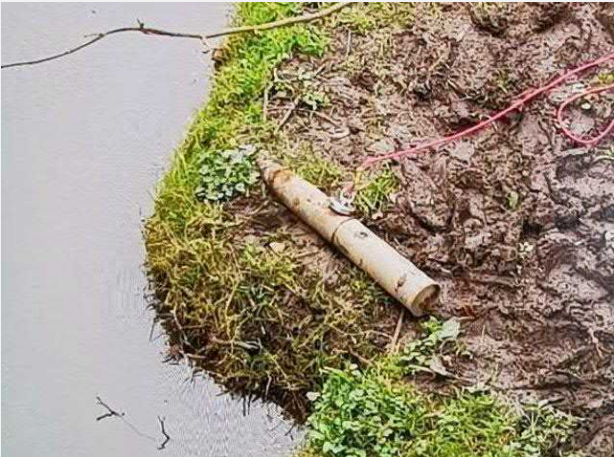
| Item(s) Discovered | Details |
|--|--|
| <p>Unexploded Shell</p> | <p>March 2021 – WWII mortar shell found by anglers in the River Avon, near Welford, Northamptonshire.²³</p> |

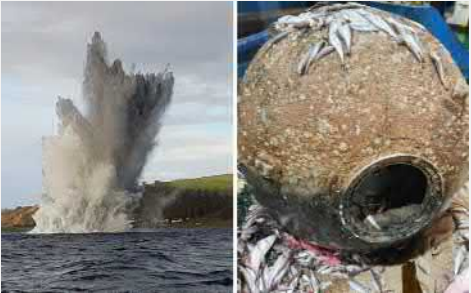
| Item(s) Discovered | Details |
|--|--|
| <p>WWII Mine</p> | <p>December 2020 – WWII German submarine-laid, moored influence mine with 350kg of explosives found in the River Clyde.²⁴</p> |

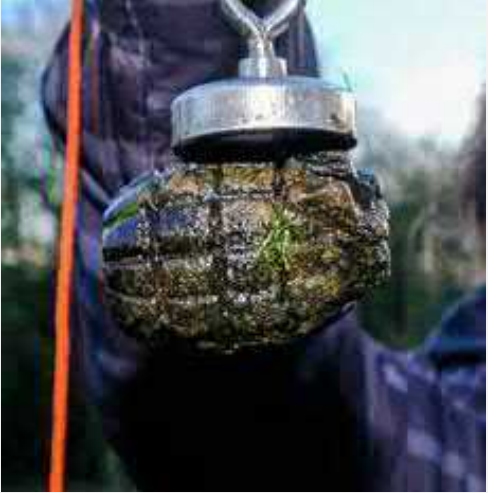
| <p>WWII-era Grenades</p> | <p>December 2020 – 19 x grenades pulled out of the River Tame on the outskirts of Birmingham.²⁵</p> |

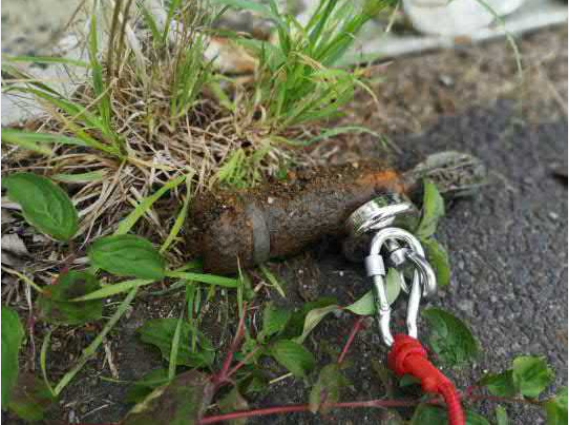
| <p>WWII-era mortar</p> | <p>July 2020 – WWII-era mortar found in the River Mole in Mickleham & Norbury in Dorking, Surrey.²⁶</p> |

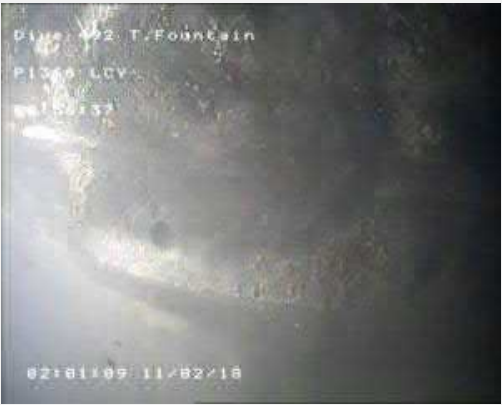
| <p>500kg German UXB</p> | <p>In February 2018, SafeLane Global discovered an unexploded WWII bomb within King George V Dock, London. This resulted in the evacuation and closure of London City Airport.²⁷</p> |

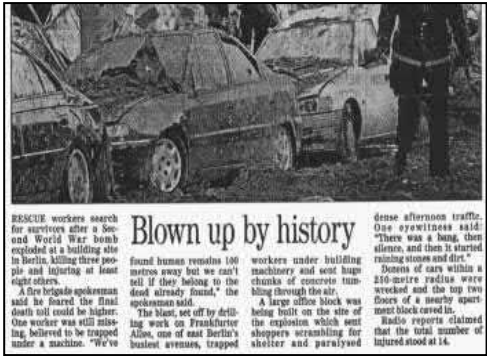
| UXB Incidents where intrusive works have caused detonation, resulting in death, injury and damage to plant | |
|--|--|
| | <p>A WWII bomb killed 3 and injured 8 in Berlin - 1944</p> |

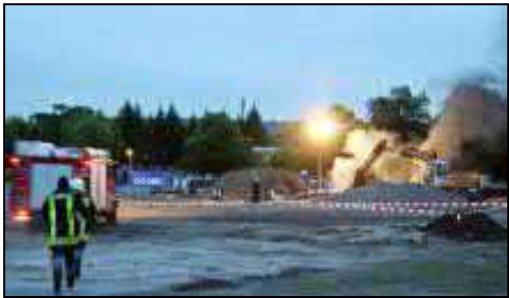
| UXB Incidents where intrusive works have caused detonation, resulting in death, injury and damage to plant | |
|--|--|
| | <p>WWII bomb killed 3 in Goettingen, Germany – 2010.</p> |

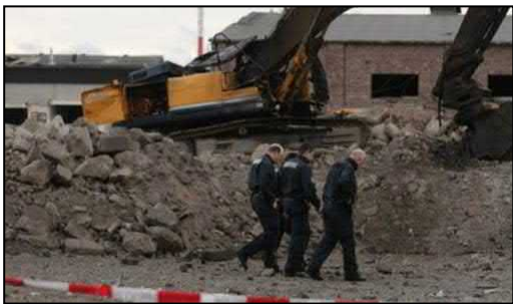
| UXB Incidents where intrusive works have caused detonation, resulting in death, injury and damage to plant | |
|--|--|
| | <p>Excavator operator killed by WWII bomb in Euskirchen, Germany – 2014.</p> <p>A WWII bomb exploded at a construction site near a west German town, killing a man and injuring 8 others. The explosion occurred with a digger accidentally struck the device during excavation works.</p> |

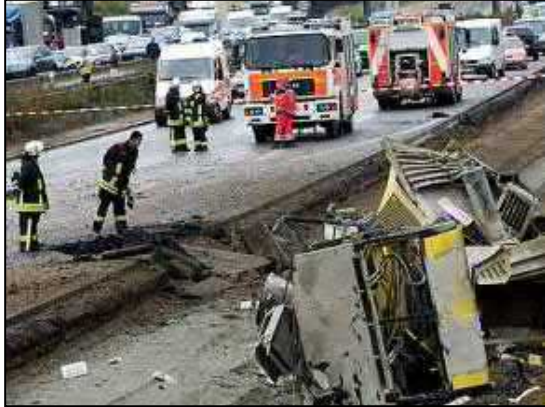
A highway construction worker in Germany accidentally struck a WWII bomb, killing himself and wrecking several passing cars – 2006.

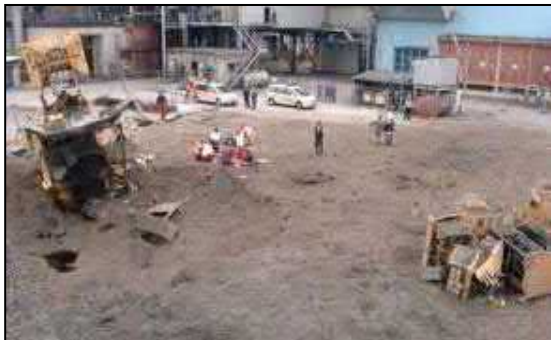
Destroyed piling rig and dump truck after detonation of WWII UXB in Austria – 2006.

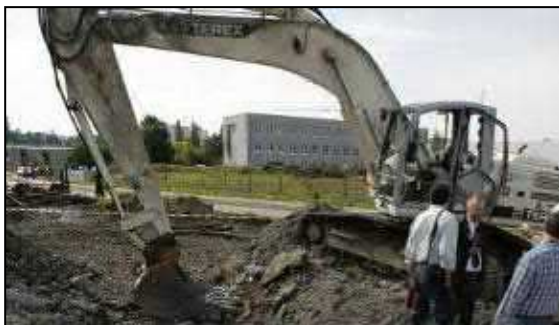
WWII bomb injures 17 at construction site in Hattingen, Germany – 2008.

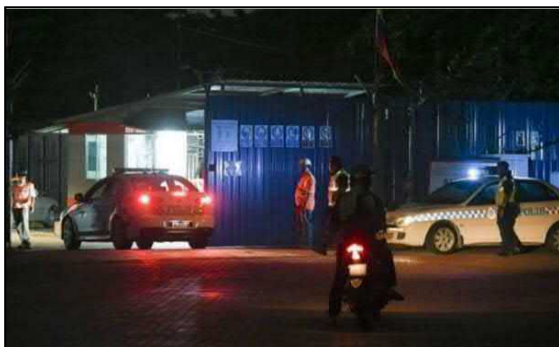
A buried WWII-era bomb exploded during construction works in Bandar Malaysia, Kuala Lumpur – 2017.

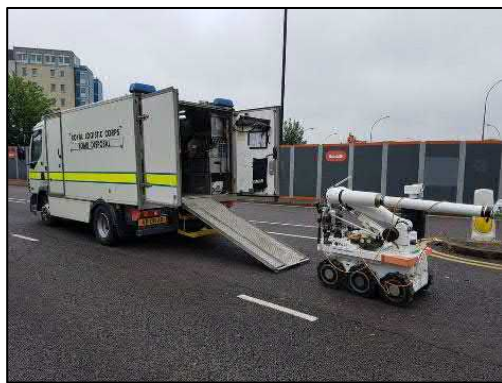
Unexploded WWII bomb found in Birmingham, causing a construction site to be evacuated.

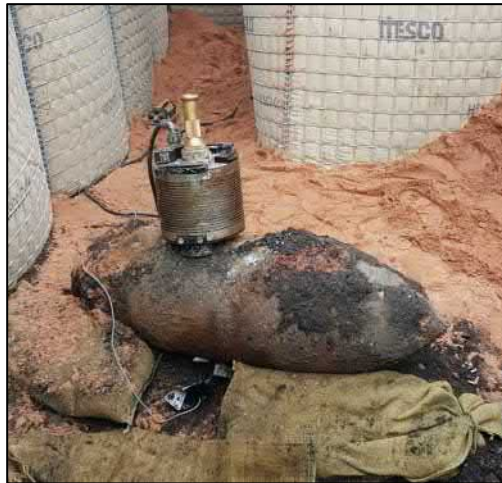
A WWII UXB was found near to the Aston Expressway, leading to the evacuation of around 200 residents and a 500m cordon.

Following the discovery, the weapon was safely detonated by the Army. However, although the M6 was reopened after the blast, the key Aston Expressway stayed shut until 6pm, extending traffic disruption. All nearby rail services and other roads were also disrupted.

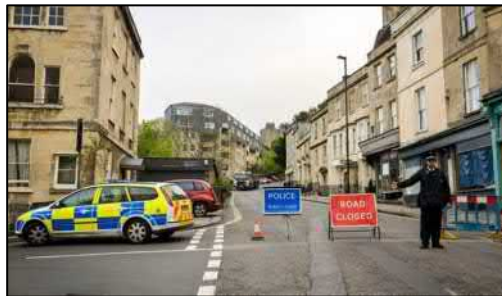
Up to 1000 homes were evacuated and a 300m exclusion zone was put in place following the discovery of a WWII UXB in Lansdown Road, Bath. The 500lb bomb was found just a meter beneath a playground at the former Royal High Junior School.
